MSU Campus Archaeology Program Project Summary Sheet

Report No. 43

Site Name: Agricultural Hall Foundation

Survey Type: Monitoring

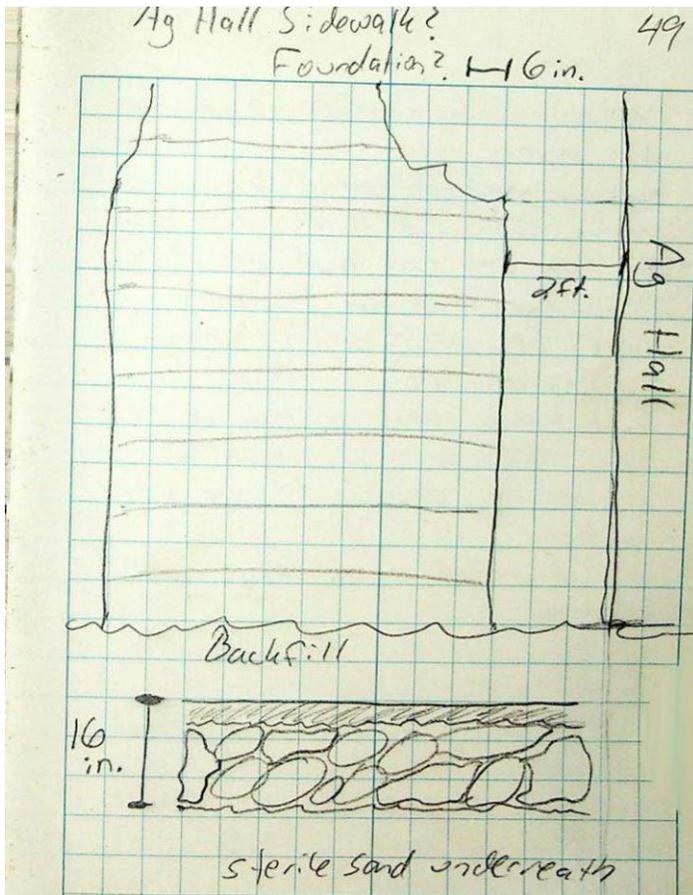
Figure 3: Sketch map showing location and profile view of the foundation feature

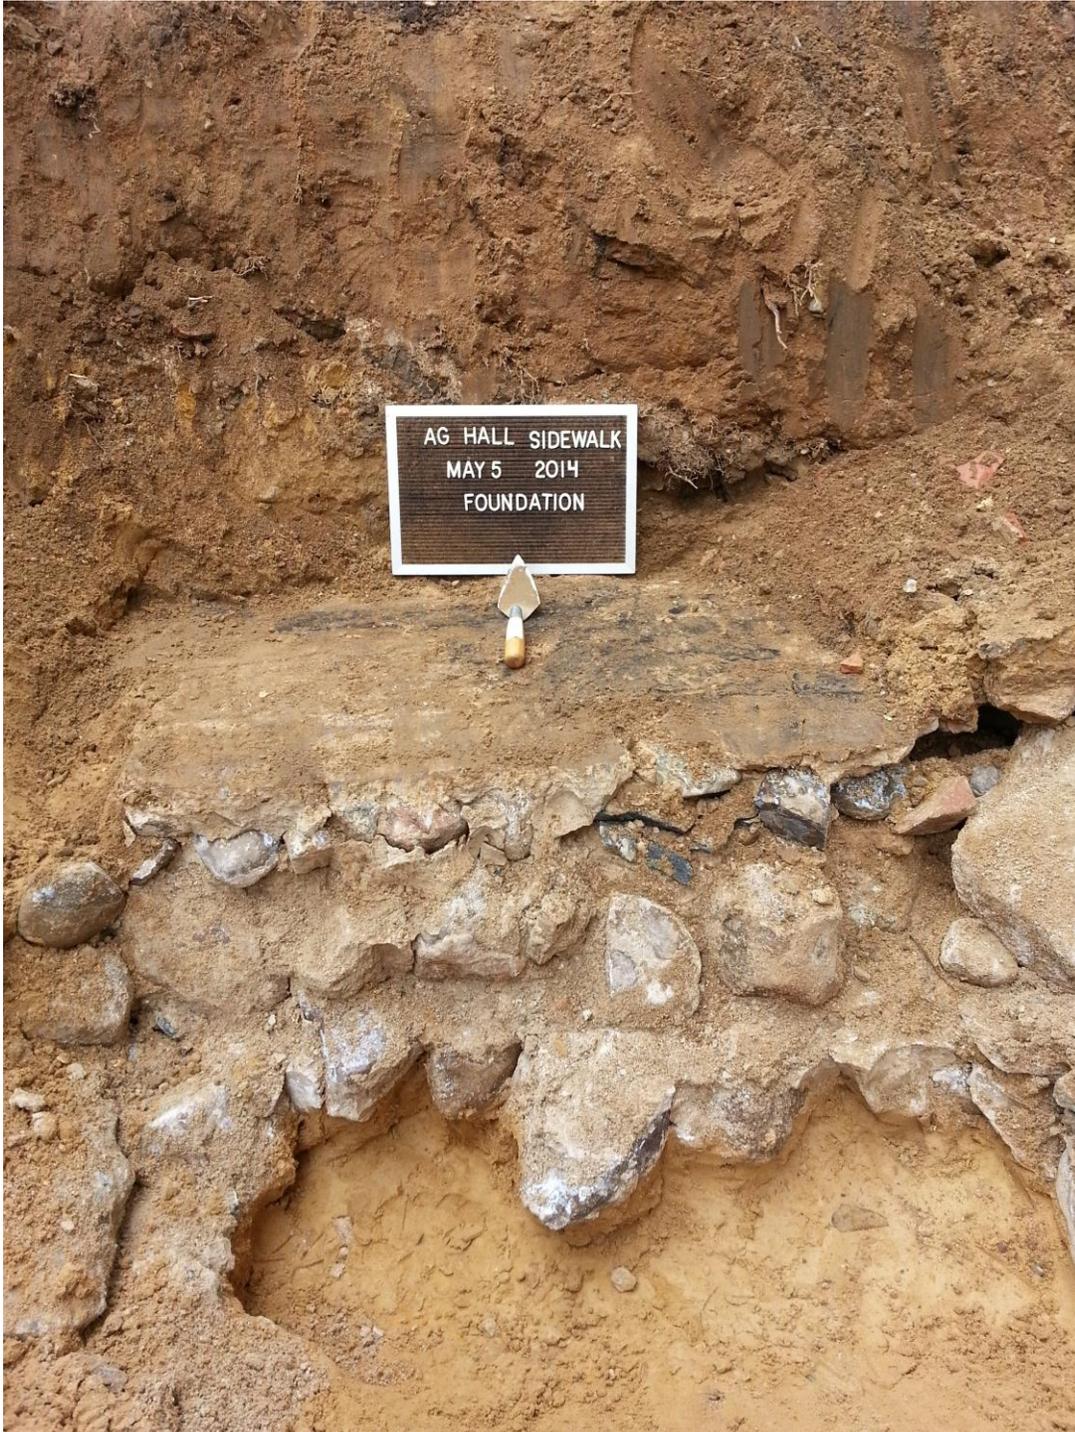
- Weather:
- Called to Ag Hall by Granger this morning
 - o Found a two-course stair structure w/ a layer of concrete [covering?] it.
 - o It is about 6x8 ft – 2-ft away from front of Ag hall
 - o **No artifacts found**
 - o Mapped, measured, and took pictures
- Bags
 - o All artifacts were collected in bags: Bag #s K44 – K54

Figure 6: Photograph of feature showing courses and concrete layer

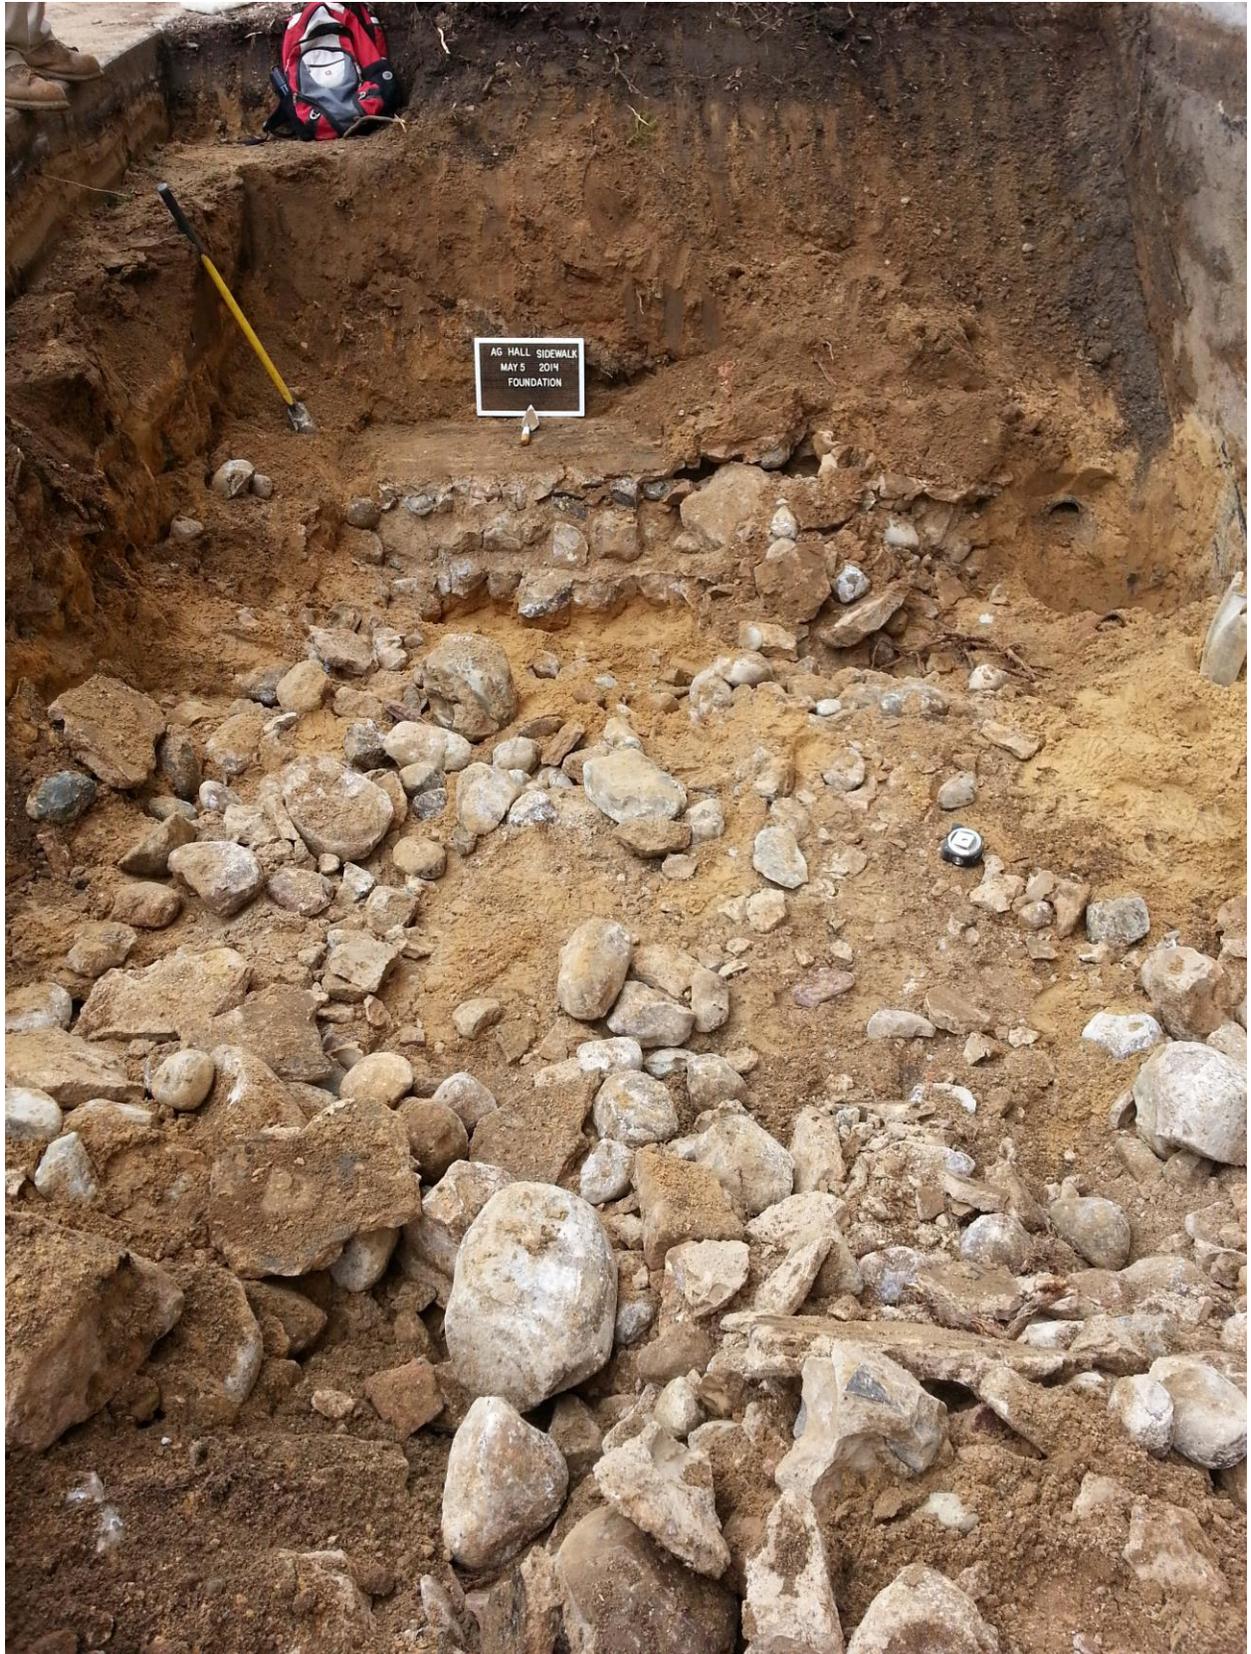
Figure 7: Photograph of feature showing surrounding rock rubble
