MSU Campus Archaeology Program Project Summary Sheet

Report No. 43

Site Name: Agricultural Hall Foundation

Survey Type: Monitoring

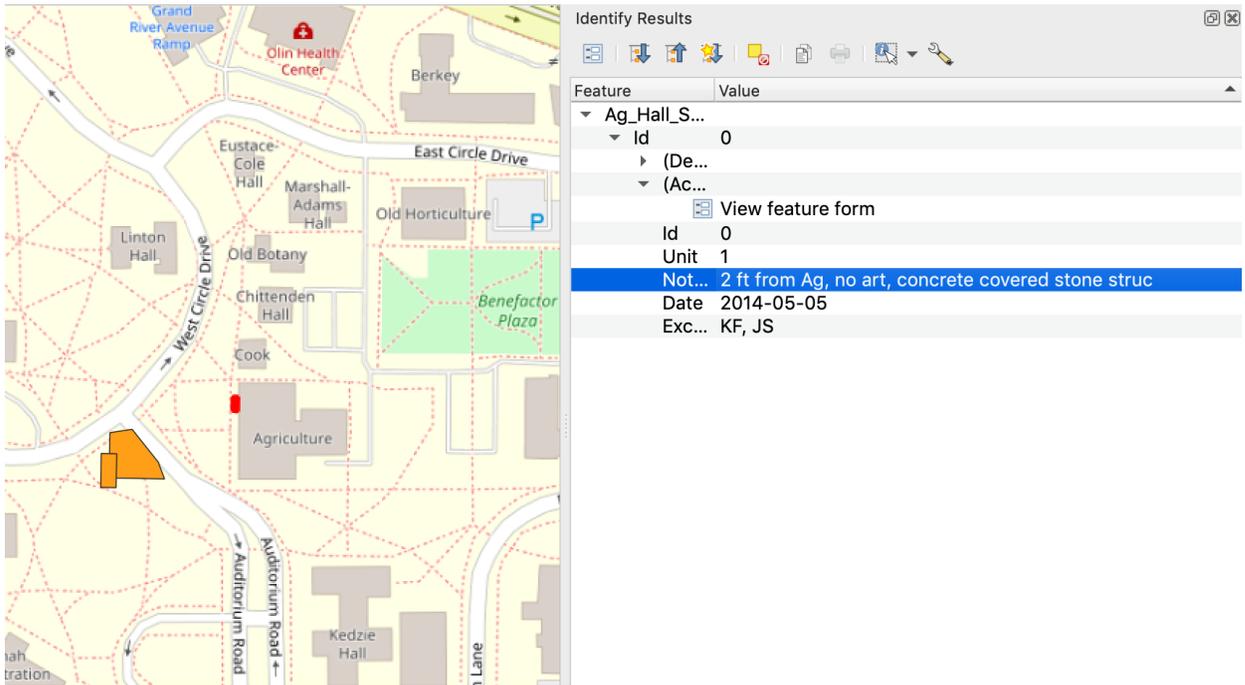
Figure 2: GIS map showing Ag Hall Foundation site (red highlight) and Ag Hall South/Vet Lab site. Also included is a description of the feature from monitoring, which states that the foundation wall was found 2 feet from the extant building, the hole contained no artifacts, and it describes the foundation wall as a “concrete covered stone [structure]”.

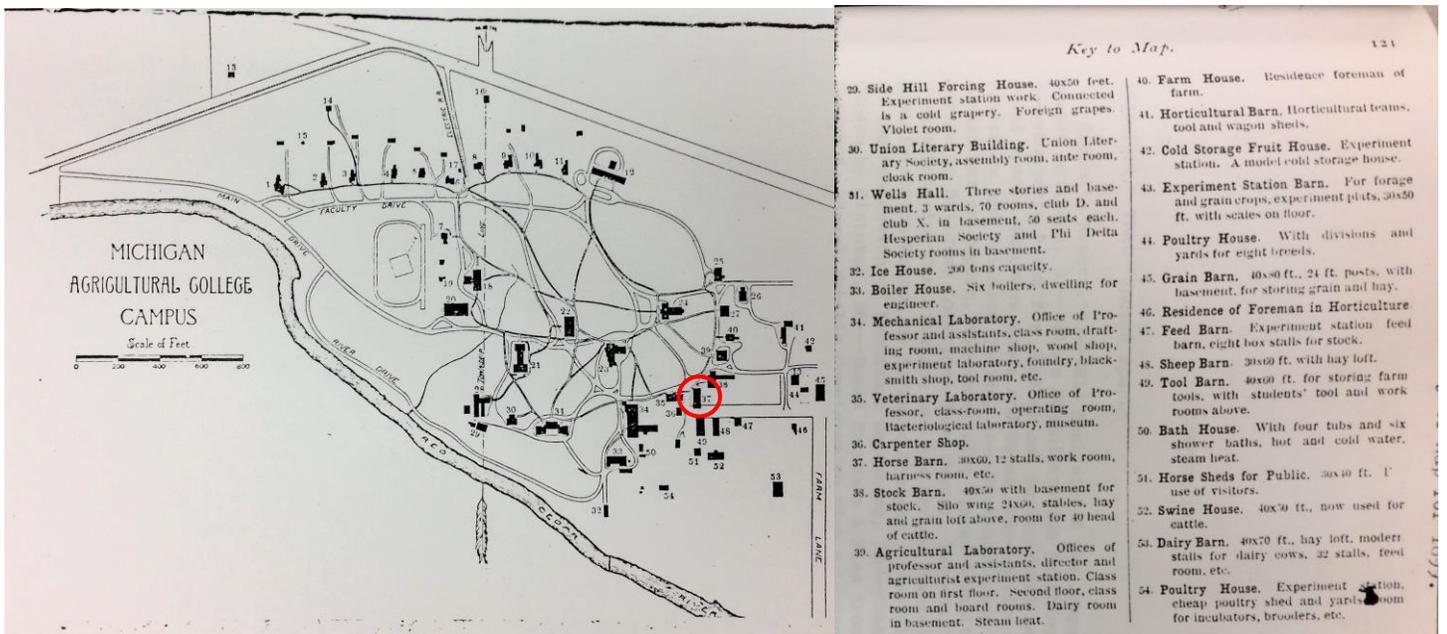
Figure 4: Map of M.A.C from 1899 showing a horse barn (37) in the future location of Agricultural Hall
